**Ambient Air Quality Monitoring Program, Update on Dust Measures and Additional information - Beenleigh Quarry - EPPR00575213**

**HOLCIM (AUSTRALIA) PTY LTD BEENLEIGH QUARRY - AIR QUALITY MONITORING**

**Re: Summary of Dust Monitoring Response to EHP Request –  
Holcim Beenleigh Quarry**

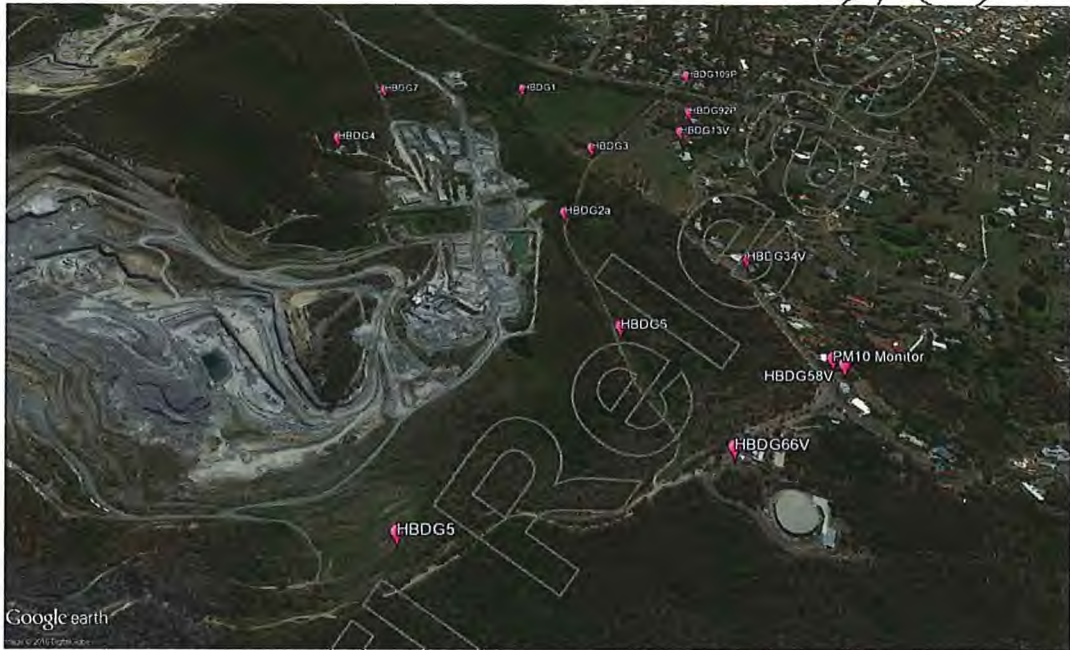
**Figure 1 – Dust Deposition Monitoring Locations**  
(source: Groundwork Plus)

The currently operational dust deposition monitoring locations are shown in **Figure 1 – Dust Deposition Monitoring Locations**.

The three new dust deposition monitoring locations, in conjunction with the existing monitoring locations HBDG58V at Vennor Drive and HBDG92P at Peachey Road, are considered to provide appropriate coverage of the Vennor Drive and Kirk Outlook residential land uses nearest to the Holcim Beenleigh Quarry.

Three additional dust deposition monitoring locations have been implemented along Vennor Drive, as follows:

HBDG13V:  Vennor Drive, Ormeau (residential property)

Sited at 2.0m height at north corner of property approximately 12m from house on adjoining property and 8m from significant tree dripline

HBDG66V:  Vennor Drive, Ormeau (residential property)

Sited at 2.0m height at northwestern corner of property approximately 9m from shed and 13m from significant tree dripline

HBDG34V:  Vennor Drive, Ormeau (residential property)

Sited at approximately 3.3m height above base of retaining wall level and 1.8m above footpath level at western boundary of property approximately 6m from house and 8m from significant tree dripline.

It is proposed to continue to monitoring at all other existing dust deposition monitoring locations shown on **Figure 1** for the balance of the September and through the October monitoring period.

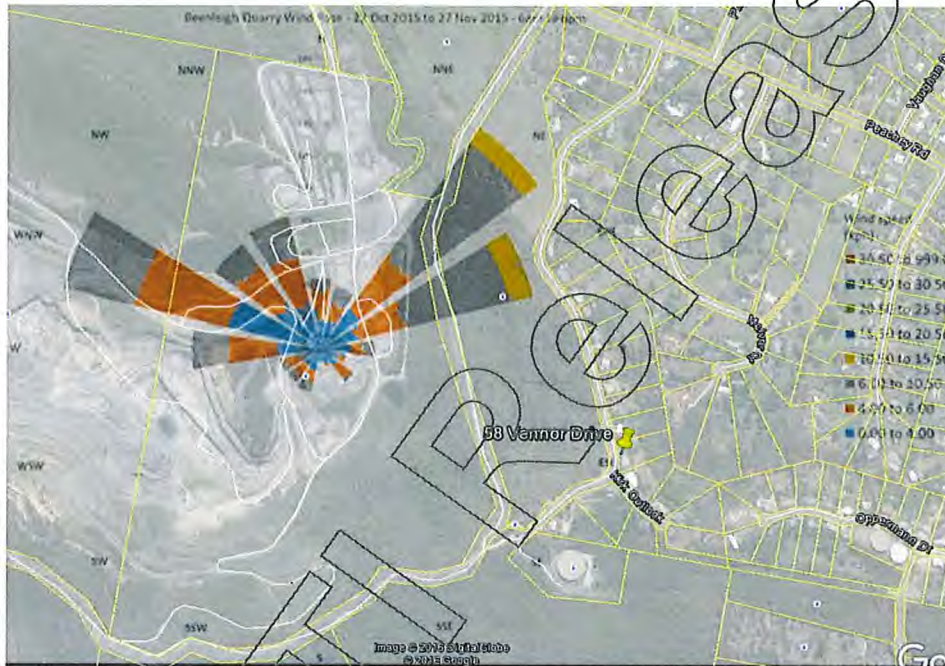
**Figure 2: 6am to 6pm Wind Rose for Available October/November 2015 On-Site Weather Station Data**

- Analysis of on-site weather station data from the Holcim Beenleigh Quarry for the available October/November period 2015 indicated a high frequency of winds that would direct dust emissions from the crushing plant, stockpile and pit areas towards Vennor Drive during the expected PM<sub>10</sub> monitoring period. A 6am to 6pm (operating hours) wind rose superimposed on the crushing plant on an aerial photograph base is shown on **Figure 2** below.

The monitoring location at  Vennor Drive was selected on the following basis:

- Elevated monitoring location with 360 degree exposure and line-of-sight to quarry
- Excellent siting opportunity in terms of clear sky angle and separation from structures

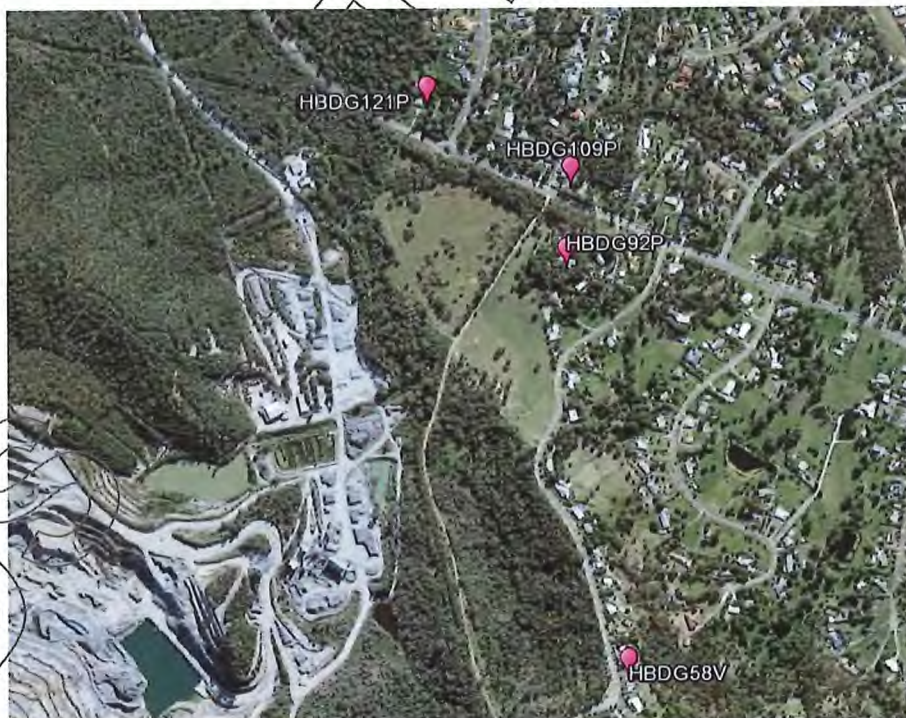
Markers below show the locations of community dust deposition monitoring.

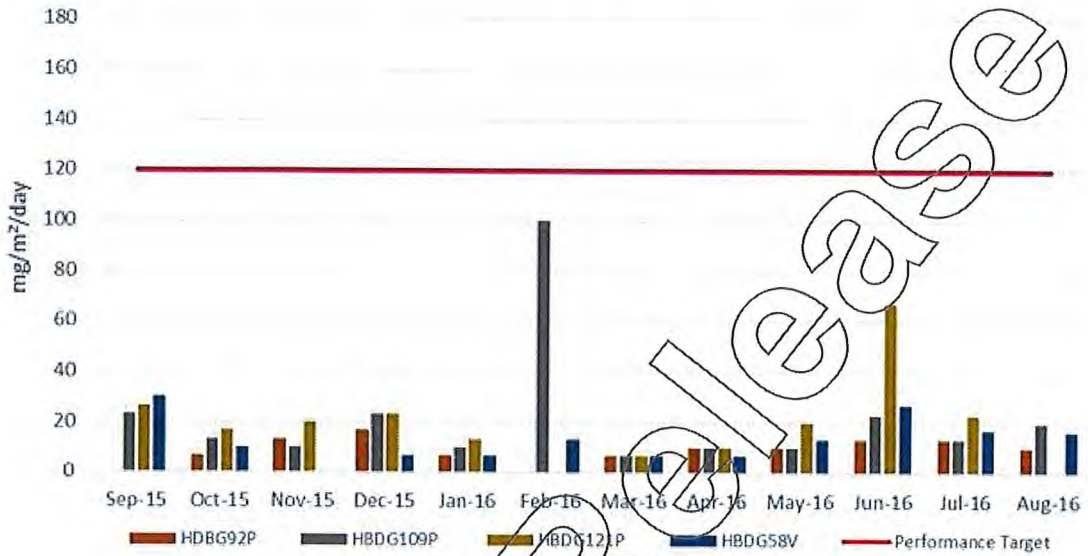
Ash Content (Non-combustible material i.e. dust from dirt road etc...)

Note: HBDG121P dust deposition bottle was decommissioned on the 20 July 2016 at the request of the owner for personal reasons. Additional dust deposition monitoring locations will be sought as a replacement including an additional location on Vennor Drive.

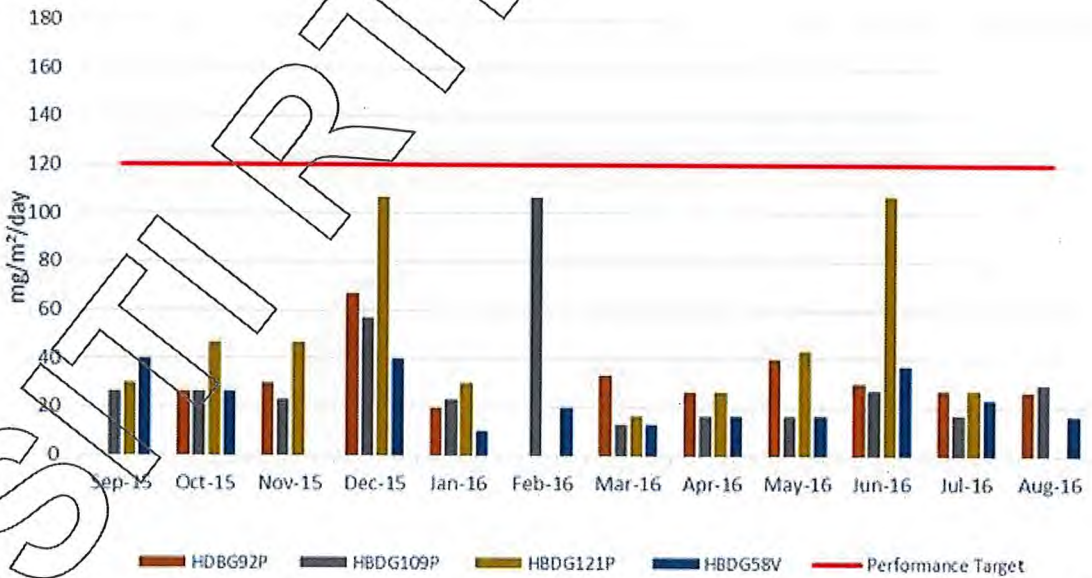
Total Insoluble Material (ash content + combustible organic material i.e. organic material, leaves, pollen, bugs)

Note: HBDG121P dust deposition bottle was decommissioned on the 20 July 2016 at the request of the owner for personal reasons. Additional dust deposition monitoring locations will be sought as a replacement including an additional location on Vennor Drive.

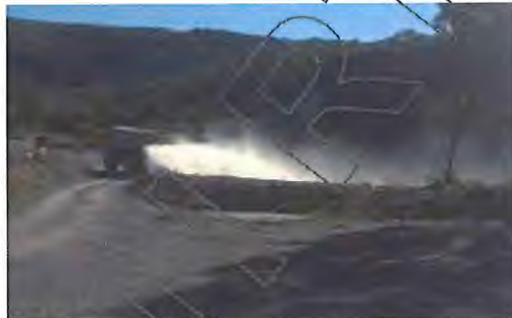
Watercart release on haul road.

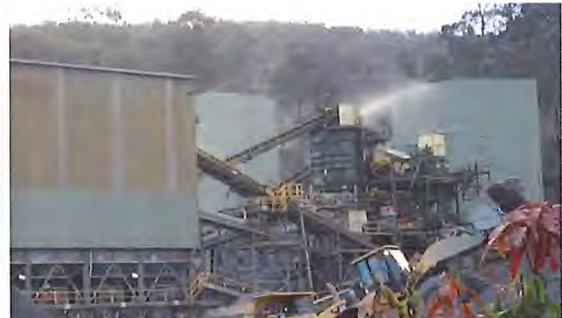
Water sprays and Coolfog™ systems in use that can appear to look like dust, especially in the afternoon sun.

- Example of CoolFog™ in operation - Please find attached a photo showing the operation of the CoolFog™ and the site's water cart, illustrating how the fog / water sprays can be mistaken for dust (**Attachment E**). These images are also available on the Holcim Beenleigh Community Website via the following link: <http://www.holcim.com.au/about-us/community-link/beenleigh/news/beenleigh-quarry-working-towards-further-dust-improvements.html>

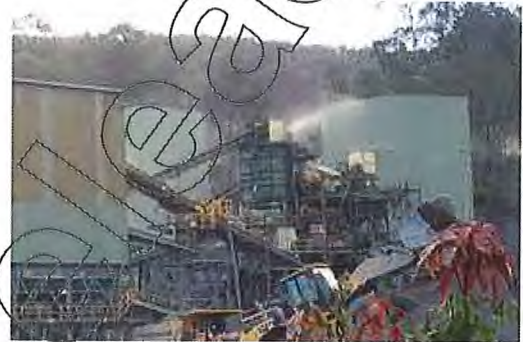
Coolfog in operation.

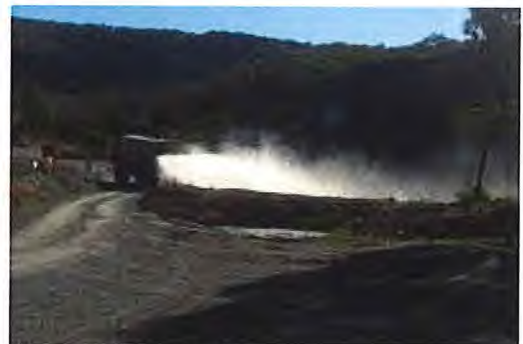
Water cart in operation.
